Report on LakeWatch Water Quality Studies at Lemon Creek Wildflower Preserve

Note: This report covers the period from July 2011 through November 2023. In October 2024, our freshwater ponds were inundated by saltwater storm surge from Hurricane Milton, resulting in high salinity levels in the ponds that will significantly change the ecosystems in the months ahead. Future study will be needed to assess the impacts.

Introduction

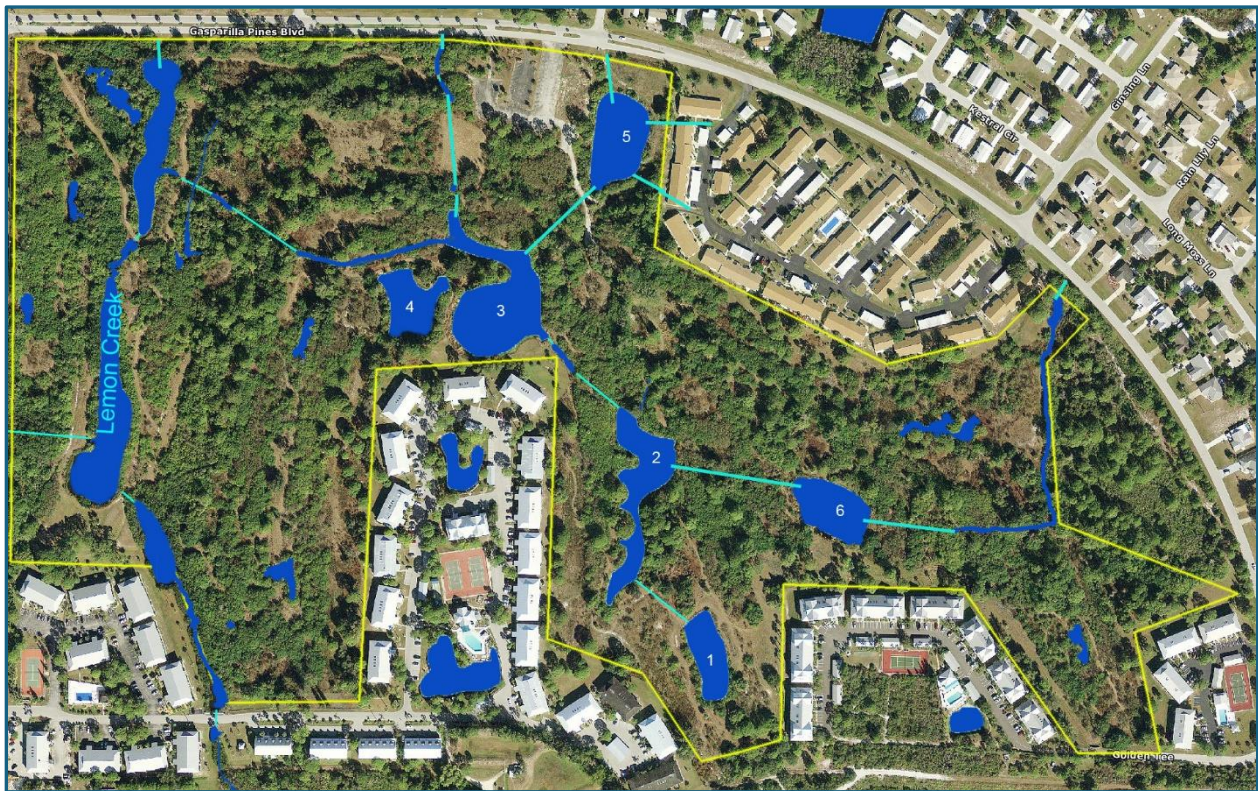
Please refer to the map for a depiction of the golf course pond and creek system prior to restoration. In LakeWatch reporting, our Ponds are designated WF1 through WF6. We'll refer to them as Ponds 1 through 6 in these discussions.

Starting on the east side, Pond 1 (Duckweed Pond) received treated sewage effluent through underground pipes from the Sandalhaven sewage treatment plant located to the south of the preserve. It was connected to Pond 2 (Long Pond) via an underground culvert (depicted in turquoise on the map).

Pond 6 (Turtle Pond) received intermittent stormwater inflows through an open ditch and connecting culverts from communities to the north. (During the dry season, the inflow ditch dried up.) Pond 6 connected via culverts to Pond 2 (Long Pond).

Pond 2 (Long Pond) connected to Pond 3 (Moorhen Pond).

Pond 5 (Verna's Pond) received stormwater inflows from neighborhoods to the north through culverts under Gasparilla Pines Boulevard and from two additional culverts that flow out of the Village at Wildflower condominium community to its east. Verna's Pond connected via culvert to Pond 3 (Moorhen Pond).

Pond 3 (Moorhen Pond) was the recipient of inflows from Long Pond and Verna's Pond. It also received stormwater via a culvert from a pond in the Sandalhaven community on the north side of Gasparilla Pines Boulevard. When Pond 3 began to fill, it overflowed to an open ditch system running to the west and eventually into the northern end of Lemon Creek.

Pond 4 (Hosman Pond) was dug sometime after the course was initially built, most likely to provide fill dirt elsewhere. It is disconnected from the other ponds.

"Fresh" water flowed into brackish Lemon Creek from several sources. At the north end, the Creek received direct stormwater inflows via a culvert from the north side of Gasparilla Road. When Moorhen Pond was high enough (water level greater than approximately 2.5' NAVD), the drainage creek from Moorhen Pond drained into the Creek a little further south. Drainage swales from Placida Road (just west of the diagram) dumped into the Creek near the tidal interchange point. Lemon Lake, to the south of the preserve in Charlotte County's Amberjack Preserve, connected to the southern end of the creek after it first passed through the Fiddlers' Green condominium complex and other properties. Lemon Creek had a tidal connection near the southwest corner of the preserve to Lemon Bay through culverts that run under Placida Road.

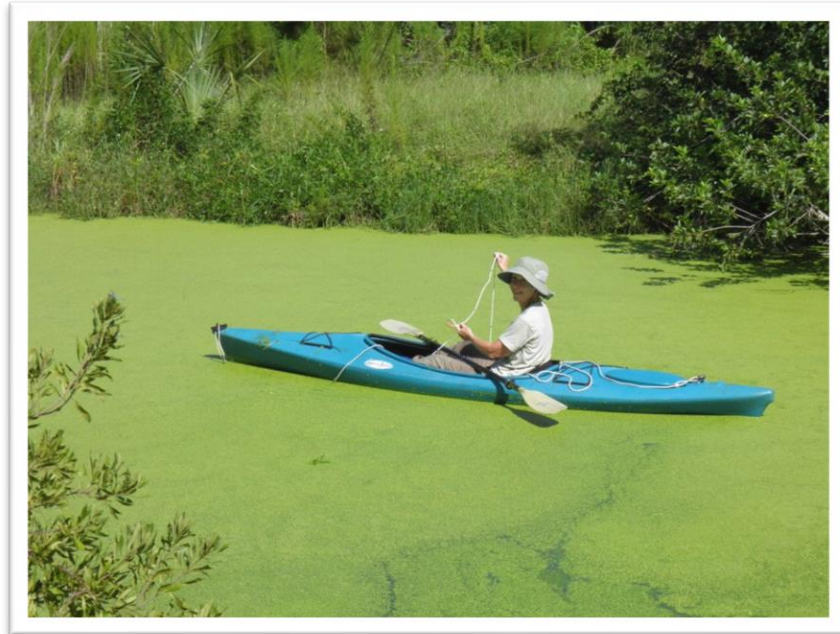
The early LakeWatch data confirmed that Duckweed Pond was extremely high in nutrients, and we focused our initial water quality improvement efforts on that pond. The photo depicts the dense growth of Duckweed covering the pond during LakeWatch sampling in August 2011.

We added a riser standpipe to the pond to stop the flow of high nutrient water from Duckweed into Long Pond unless water levels in the pond rose to elevated levels (approximately 4.0' NAVD). We installed floating islands in the pond with plants designed to absorb excess nutrients. We used a net and pump system to periodically harvest duckweed from the pond and thereby remove nutrients contained within the plants. And, we installed a solar pond aerator to increase oxygen levels in the water.

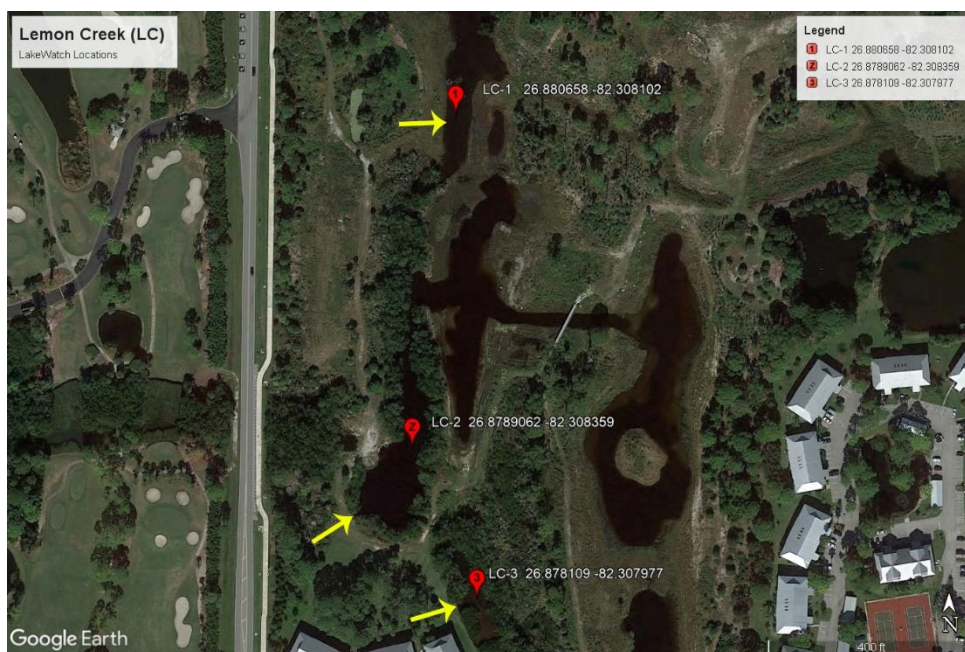
The map below shows the three locations in Lemon Creek where we collect water samples. In the LakeWatch reports, the creek locations are referred to as LC1, LC2, and LC3.

All three locations are in the “old” part of the creek, this is in areas that existed prior to our restoration work expanding the creek system.

LC1(Lemon Creek North) is the closest location to the point where freshwater flows into the creek from Pond 3 when water levels are high. The north end of the creek also receives stormwater inflows from a drainage pipe running under Gasparilla Pines Boulevard. The creek area around LC1 was expanded as part of the restoration work, so there are fewer mature mangroves in this part of the creek than at the other two monitoring locations.

LC2 (Lemon Creek Central) is close to the point where tidal exchange occurs between Lemon Creek and Lemon Bay. Culverts run under our preserve trail west of the sampling location, through the mangroves, and through additional culverts under Placida Road. Water quality here is also influenced by drainage swales that run along the east side of Placida Road and dump stormwater into the creek. Mature mangroves cover most of the creek banks in this area. Hurricane Ian caused considerable damage, particularly to the red and black mangroves that are in the immediate tidal flow zone closest to Placida Road.

LC3 (Lemon Creek South) is in the southern portion of our property in a narrower section of the creek surrounded by mangroves. This portion of the creek flows through the Fiddlers’ Green condominium community and connects to Lemon Lake in the County’s Amberjack Preserve.
